RECALL: This modification has top priority and must be performed immediately to ensure customer safety

Subject: Inspection, Repositioning, and Securing of the wiring harness routing

**Affected Models: 2013, 2014, 2015 and 2016 1190 Adventure
2013, 2014, 2015 and 2016 1190 Adventure R
2015 and 2016 1290 Super Adventure**

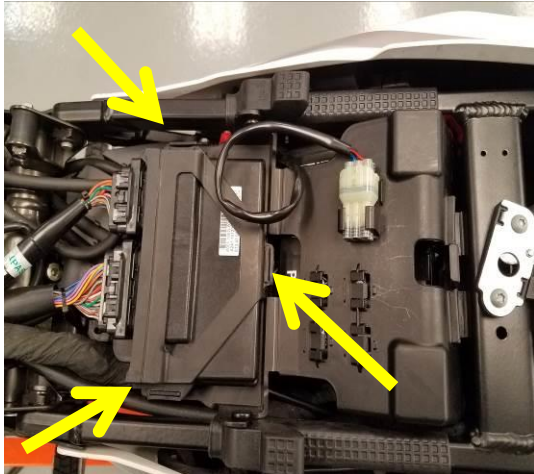
(Fig 1)

- » Remove the passenger and front rider's seat.
- » Pull off the ECU including the rubber strap. **(Fig 1)**

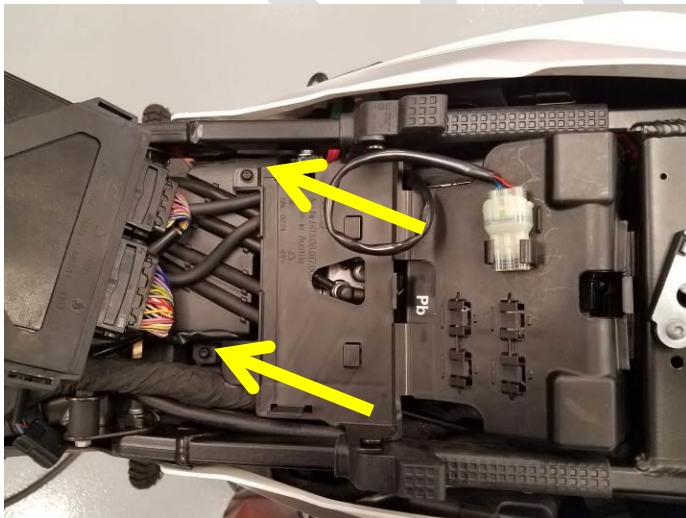
(Fig 2)

- » Remove the two screws for the battery cover and remove the cover. **(Fig 2)**

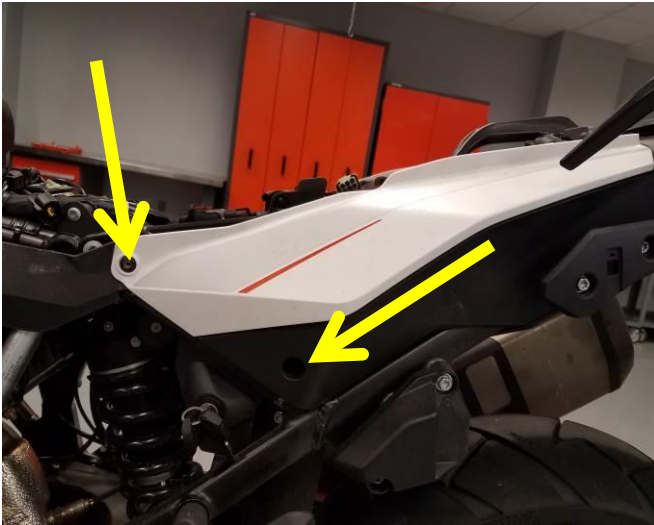
(Fig 3)

- » Remove the two screws on the left-hand side cover and remove the cover. **(Fig 3)**

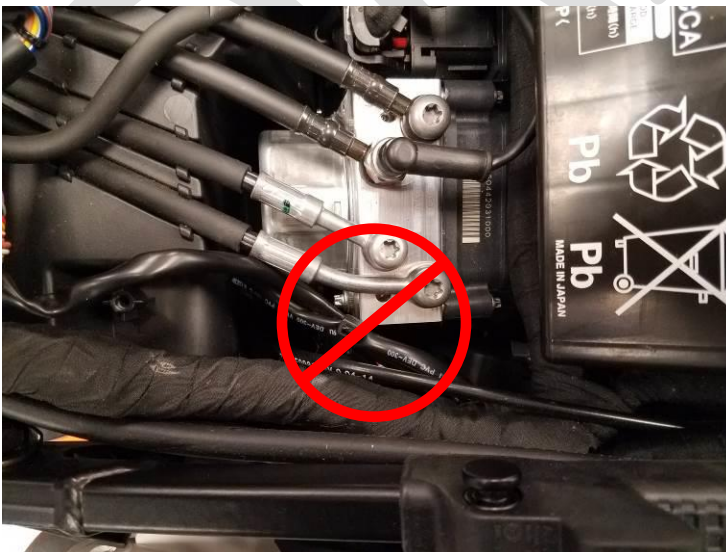
(Fig 4)

- » Check the wiring harness for visible damage around the ABS modulator (chafing, damaged coating, exposed wires, etc.) Take a photo of the damage if any exists.
- » If the dealer finds a damaged wiring harness they should contact dealer services with a description of the damage.
- » Check the routing of the entire wiring harness around the ABS modulator.

Fig 4 displays incorrect routing and requires repositioning and securing as shown in next step. **Fig 5**

- » Use cable ties to secure the wiring harness, sensor line and voltage regulator line under the frame tube. Take a photo of the repositioning of the wiring harness and cable tie placement so you can attach it to the warranty claim.

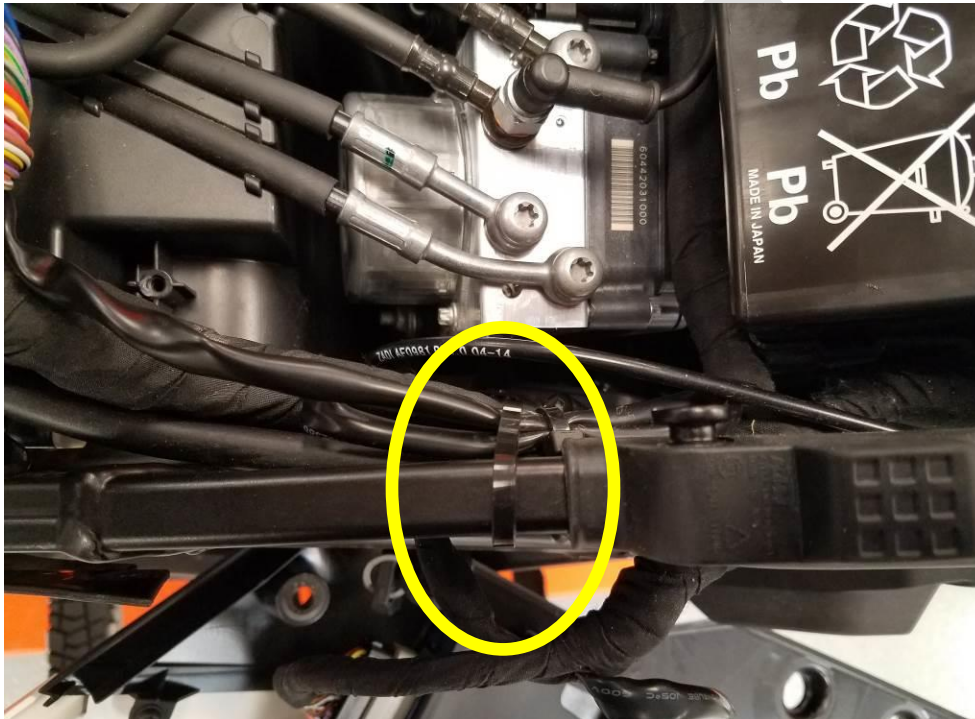
The passenger seat lock cable should **NOT** be fixed with the cable tie. (Fig 5)

- » The cable tie must not be too tight.

Please observe: The minimum clearance between the ABS modulator and an electrical line must be at least **20 mm**.

- » A photo of the completed repair must be attached to the claim showing the repositioning of the harness wires and cable tie mounting. See Figure 5 for an example.
